TREE PRESERVATION REPORT FOR ZONING BY-LAW AMENDMENT

**767 SOUTHDALE ROAD EAST,
LONDON, ONTARIO**

Report prepared by
Ron Koudys Landscape Architects Inc

RKLA Project #25-150

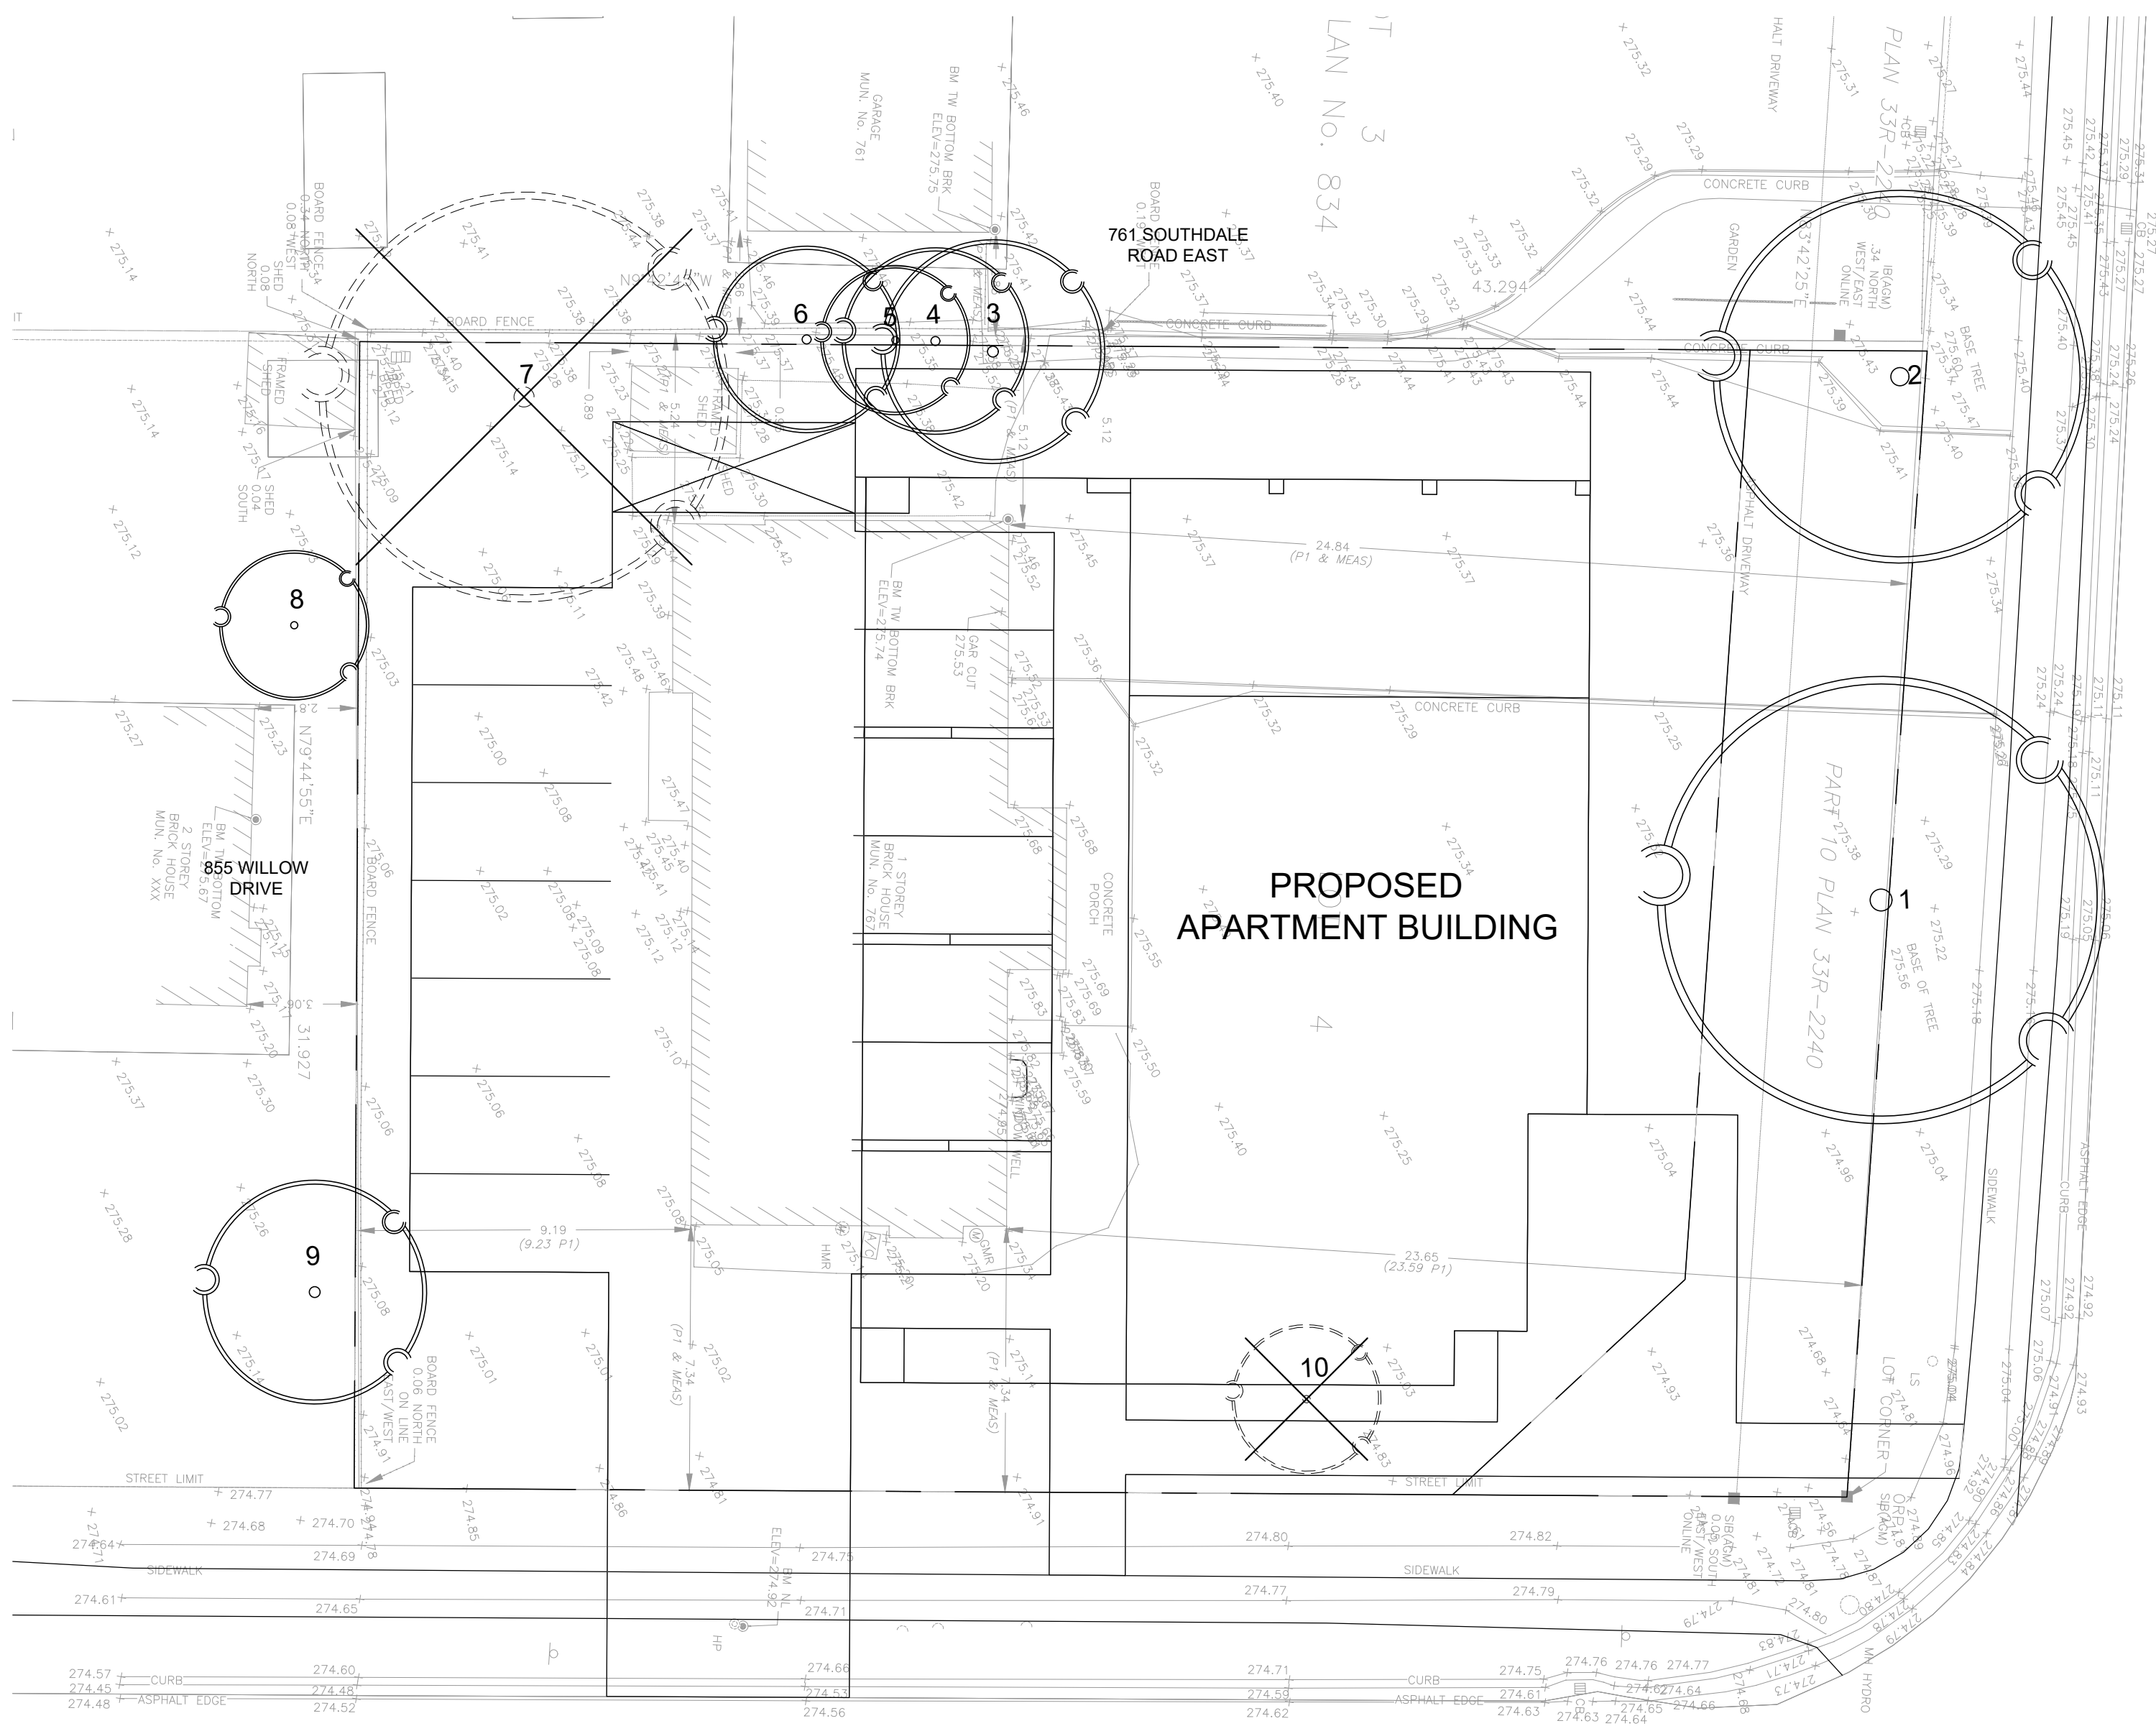
TREE PRESERVATION PLAN
SCALE =1:150

| RECOMMENDED PRESERVATION | | | | | | | | | | | | | |
|---|---|---|---|---|---|---|---|---|---|---|---|--|--|
| 1 | <i>Acer saccharum</i> | Silver Maple | City ROW Southdale Road | 11 | 6 | 4 | Poor | Fair | Major dead limbs, epicormic growth, lots of burrs. | potential impacts - review at the time of SPA | preserve | consent from City Forestry if removal is required | |
| 2 | <i>Acer saccharum</i> | Silver Maple | City ROW Southdale Road | 96 | 5 | 4 | Poor | Fair | Covered in ivy, large burrs, major deadwood. | potential impacts - review at the time of SPA | preserve | consent from City Forestry if removal is required | |
| 3 | <i>Morus alba</i> | White Mulberry | Boundary with 761 Southdale Road E | 45 | 3 | 3 | Poor | Poor | Epicormic growth, witches broom, cavities on trunk. | potential impacts - review at the time of SPA | preserve | consent from 761 Southdale Road E if removal is required | |
| 4 | <i>Acer platanoides</i> | Norway Maple | Boundary with 761 Southdale Road E | 22 | 25 | 5 | Fair | Fair | Basal bark removed, leaning. | potential impacts - review at the time of SPA | preserve | consent from 761 Southdale Road E if removal is required | |
| 5 | <i>Acer platanoides</i> | Norway Maple | Boundary with 761 Southdale Road E | 17, 26 | 2 | 4 | Poor | Fair | Partially fence grown, major wounds on small stem. | potential impacts - review at the time of SPA | preserve | consent from 761 Southdale Road E if removal is required | |
